Flood Irrigation Tailwater in Jackson County: Summary of Case Studies 2009-2016

The purpose of the tailwater monitoring effort by Jackson Soil and Water Conservation District (JSWCD) was to establish a baseline of pollutant concentrations (*Escherichia Coli*, temperature and turbidity) that flood irrigation water picks up as it moves across cattle pastures or hay fields. The summary includes monitoring done on 5 separate irrigation efficiency projects before best management practice (BMP) implementation. Post completion monitoring was not necessary because tailwater was at trace levels or non-existent as a result of the BMP implementation and the pollutants were therefore removed from the impacted waterways. BMP's implemented were conversion from flood irrigation to pressurized sprinkler irrigation and irrigation water management.

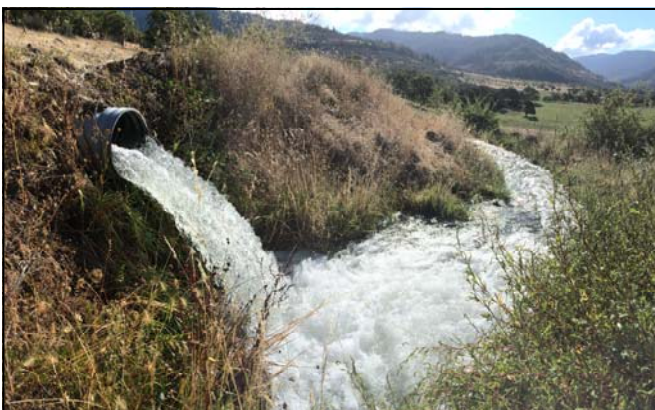
Flood irrigation water being applied from the main canal to the head ditch before spreading onto the field.
